**White Farm Equipment Company**  
WHITE MOTOR CORPORATION

## Service Bulletin

Location Charles City  
Subject Transmission Disengagement —  
1250A, 1255, 1265, G350,  
1355, 1365, G450  
Number 430 571  
Date 6-28-73  
File C Transmission

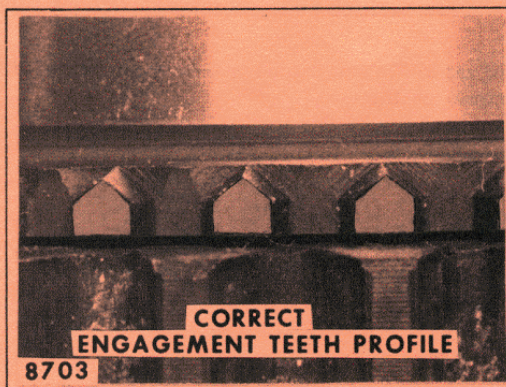
*Fig. 1 Correct Engagement Teeth Profile*

Incorrect machining of engagement teeth on synchromesh gear may not allow enough contact with drive collar teeth to maintain engagement (Figs. 1 and 2).

If problem exists purchase and install new synchromesh gear.

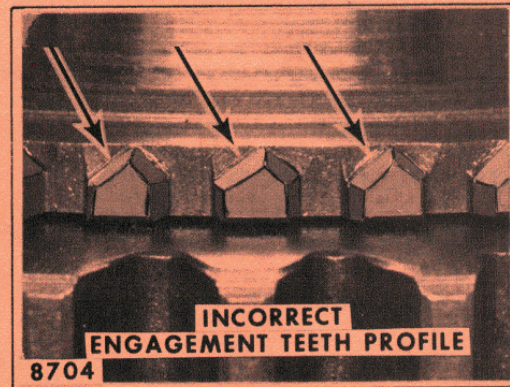
*Fig. 2 Incorrect Engagement Teeth Profile*

Possible gear disengagement due to incorrect machining of engagement teeth on synchromesh gear.
