White Farm Equipment Company

Service Bulletin

Location: Charles City
Subject: 1255, 1265, 1355, 1365
Transmission Seizure
Number: 430 594
Date: 10-16-73
File: C Transmission
1 of 2

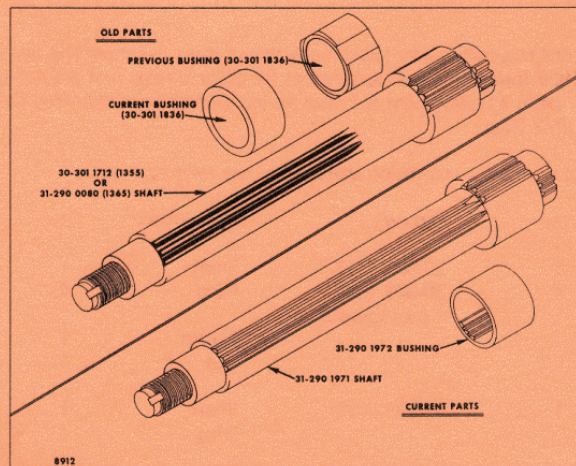
Old and New Transmission Parts

Possible transmission inner ring (Bushing) seizure on some 1255, 1265, 1355 and 1365 tractors.

Bushing may seize in driven gear. Seized bushings may rotate on lower transmission shaft resulting in failure of shaft.

1265 and 1365 production models are now equipped with inner rings splined directly to driven shaft to prevent rotation on shaft. Bushings are phosphate coated to prevent seizing in driven gear.

Repair bushings for tractors not requiring a new lower transmission shaft are phosphate coated and do not have four flat areas machined on them.

If problem exists purchase and install 31-290 1988 Phosphate Coated Inner Rings.

If problem exists on tractors not requiring a new lower transmission shaft, purchase and install 30-301 1836 Phosphate Coated Inner Rings. 30-301 1836 Inner Ring is a replacement for original rings that are not splined to driven shaft. Do not use 30-301 1836 Inner Ring as a replacement for rings having splined inner diameter. Original rings having splined inner diameter order 31-290 1972 Ring.
