<p>Service Bulletin</p>	File	GB-26-111 (Rev. 1)
	Subject	Connecting Rod Bolts 283 and 310 Cubic Inch Engines
	Date	1-25-85
	Page	1 of 3

Connecting rod bolt failures on some 1755, 1855 and 1955 tractors.

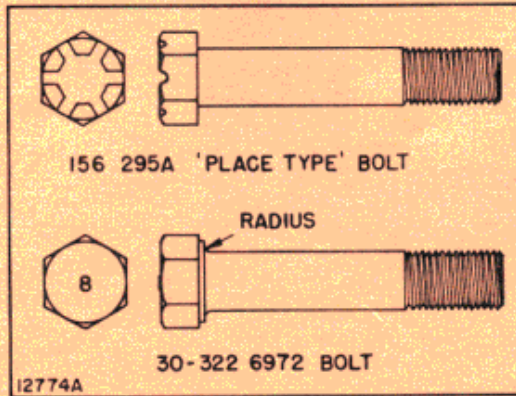
Fig. 1 Old Connecting Rod Bolts

3. Some failures are related to radius on 30-322 6972 Bolt and chamfer in connecting rod cap. (Figures 1 and 2.) Here two situations can exist:
 - 3.1 Rod cap was not chamfered on early engines because of the design of the 156 295A Place Bolt. When 30-322 6972 Bolt is used with this design cap, interference exists and proper clamping action cannot be obtained.

- 3.2 Or, chamfer has been added in the field and is not properly machined either not eliminating the interference, or chamfer is too large which reduces head contact with cap.
